# Evaluation of Slope Stability in an Urban Area as a Basis for Territorial Planning: A Case Study

**Abstract:** Slope stability is determined by pre-conditioning and triggering factors. The evaluation of the stability by scientific criteria provides crucial input into land-use planning and development. This work aimed to evaluate the slope stability of “Las Cabras” hill (Duran, Ecuador) through geological and geotechnical analysis and a susceptibility assessment that allowed the definition of areas potentially susceptible to landslide and detachment for land planning recommendations. The methodology included (i) analysis of background information about the study area; (ii) fieldwork, sampling and laboratory tests; (iii) assessment of susceptibility to landslides and detachment through a theoretical-practical evaluation (using suggestions by various authors); (iv) a safety factor assessment employing the simplified Bishop method; and (v) analysis of the relationship between susceptibility and stability. Sixteen geomechanical stations were evaluated. Of these, seven stations are characterised as category III (medium susceptibility), six stations as category IV (high susceptibility)

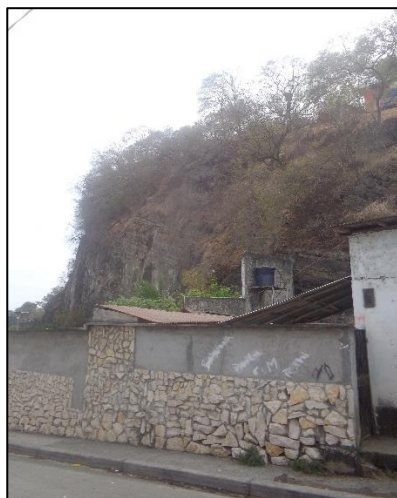
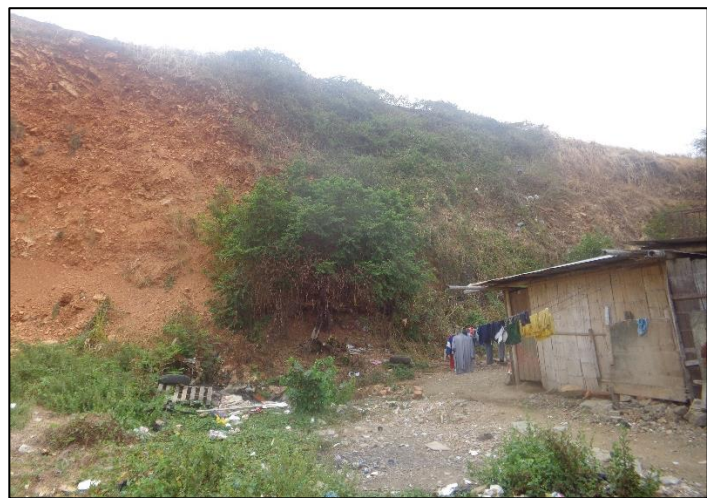
Figure 4. (a) Sandstone rock mass with intercalations. (b) Lateritic soil product of residual shale weathering.
